# Design Study Memorandum

## Tasha Drive Reconstruction

MOA PM&E Project #20-15

December 2022

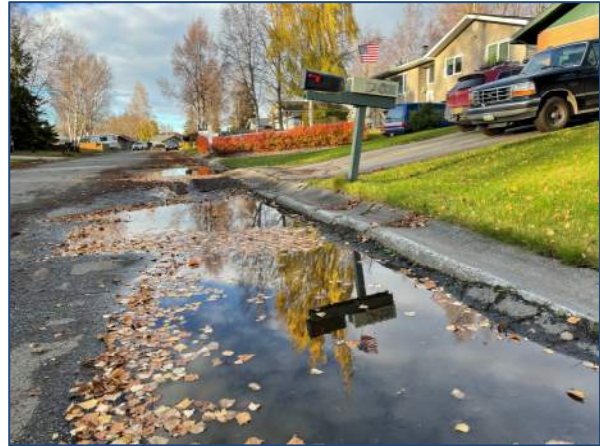
The existing roadway is in poor condition with cracked pavement and heaved, irregular curbs. These conditions lead to potholes, puddles, an uneven traveling surface, and increased maintenance costs. The purpose of this project is to reconstruct the roadway, improve drainage, alleviate maintenance issues, upgrade the roadway lighting, and provide a stable base to extend the life of the roadway.

*Existing Ponding and Heaved, Irregular Curbs*

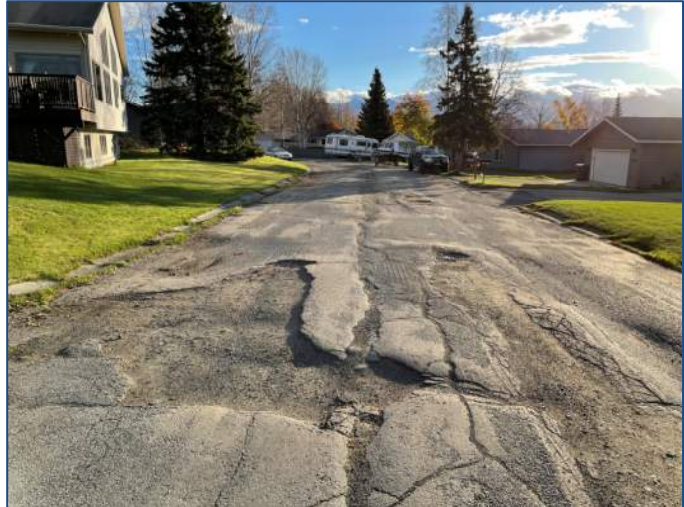
The existing roadway pavement conditions are very poor with cracking, settling, and heaving especially east of Kathleen Drive. Rolled curb and gutter is present along the entire project corridor, however, some sections of curb are broken and undulating.

*Existing Roadway Pavement Conditions*

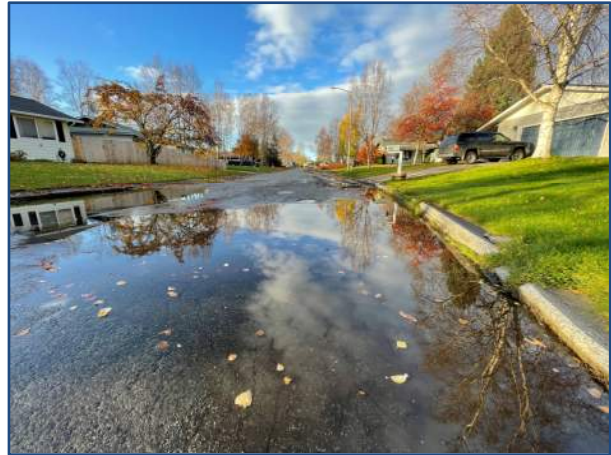
*Ponding and Heaving Curb & Gutter*

The condition of the existing pavement and curb and gutter is very poor with cracking, settling, and heaving along Tasha Drive. High groundwater and poor soils were identified during the geotechnical investigation. These conditions have resulted in the roadway degradation issues noted above. Additionally, Tasha Drive experiences ponding in low lying areas that don't effectively drain, further exacerbating the issue. These conditions are worsening over time, causing increased maintenance costs for MOA. The poor road conditions have grown to be an issue and burden for residents on Tasha Drive, as was noted during the public involvement (PI) outreach efforts (see [APPENDIX I](#) for a PI summary).

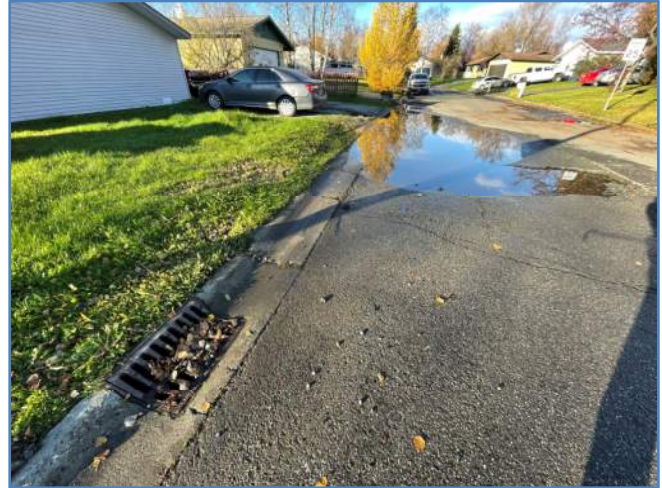
*Ineffective Catch Basin / Ponding Upstream*

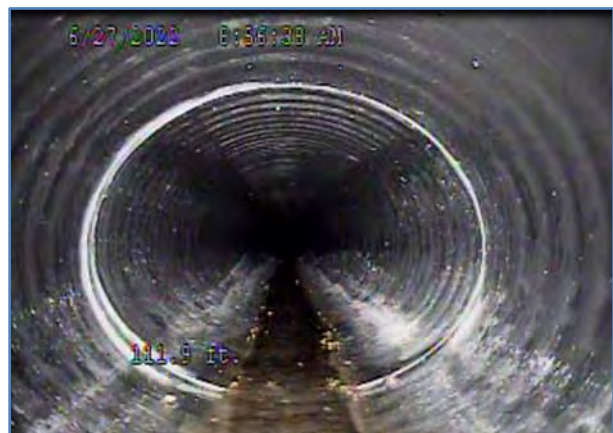
- 18-inch CPEP, Type SP (284 LF)
- Offset joints
- Pipe ovality/deformation

Photo 1 - Pipe 25631 (Ovality)

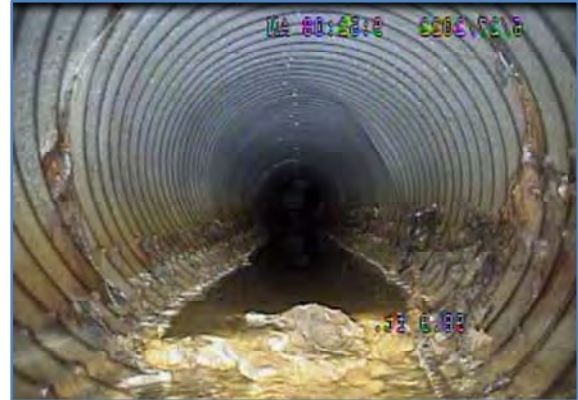
- 24-inch perforated CMP (204 LF)
- Debris/blockages in pipe
- Infiltration/mineralization at pipe perforations
- Fair condition

*Photo 2 - Pipe 28650 (Mineral Deposit at Pipe Joint)*

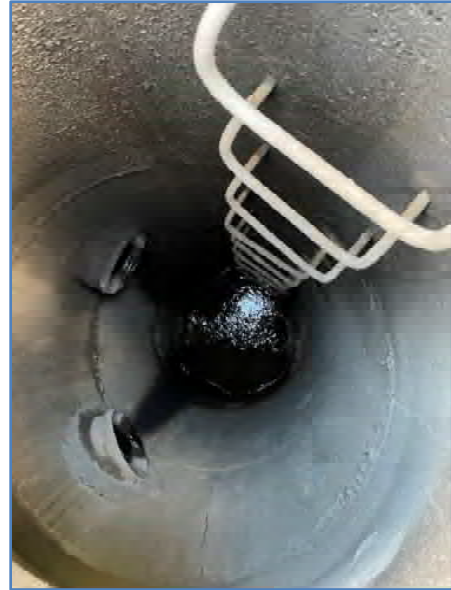
- Spalling and concrete loss from grade rings
- Metal shims/spacers inserted into grade ring gaps
- Minor cracking/spalling at pipe penetrations
- Fair condition

*Photo 3 - Interior of Manhole 32327-037*

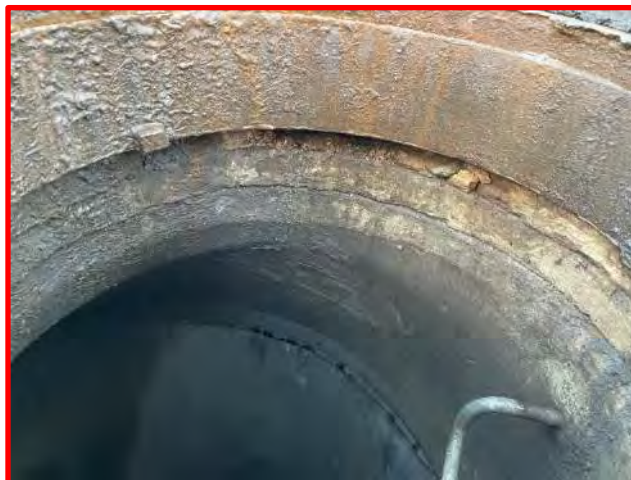
*Photo 5 - Grade Ring Damage*

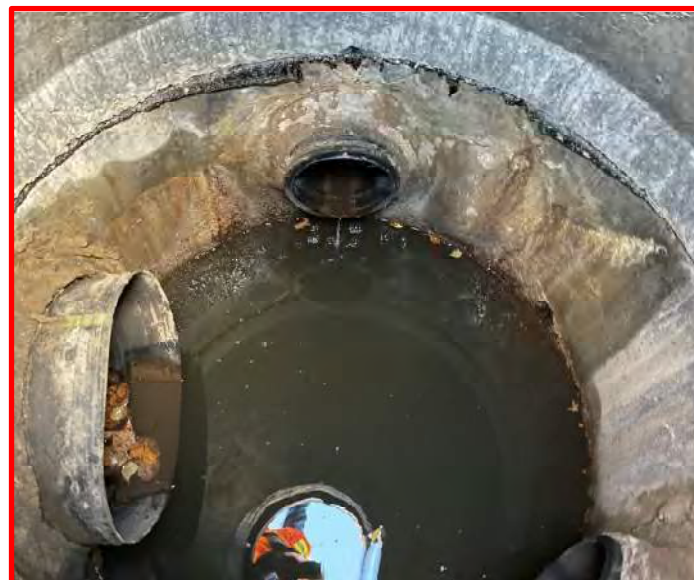
*Photo 6 - Infiltration at Base/Cone Joint*

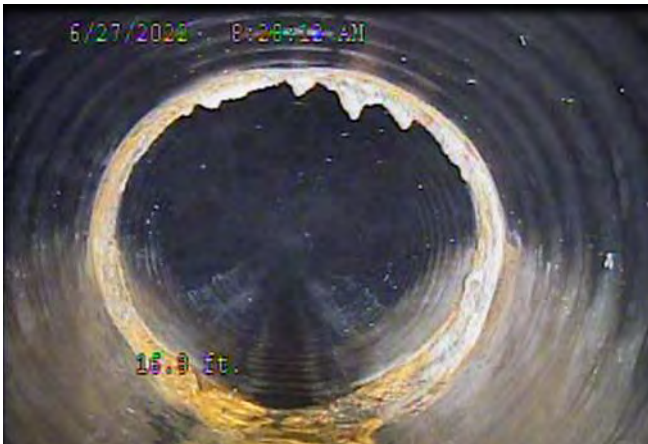
Photo 1: Infiltration/mineralization

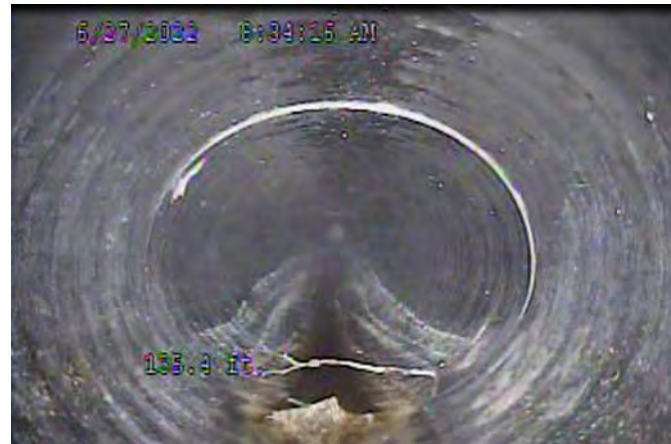
Photo 2: Debris and pipe ovality

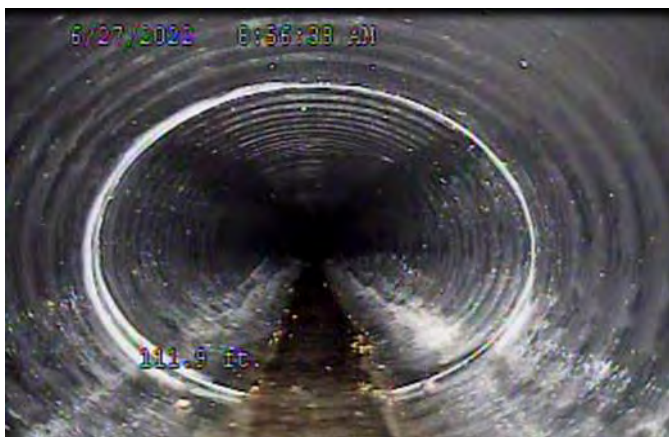
Photo 1: Pipe ovality

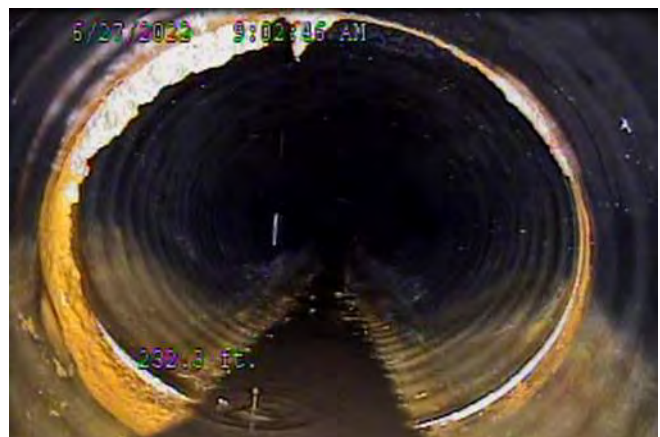
Photo 2: Infiltration/mineralization and belly at pipe joint

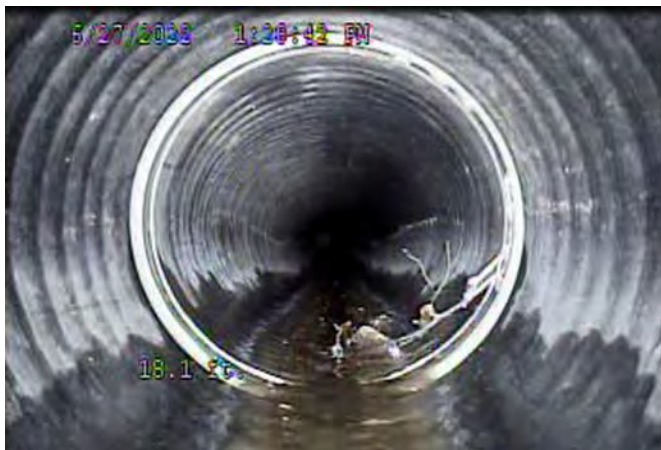
Photo 1: Separated joint & debris

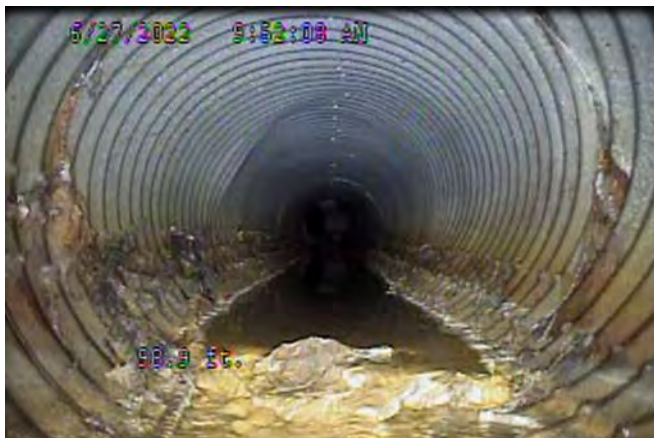
Photo 1: Mineral deposits

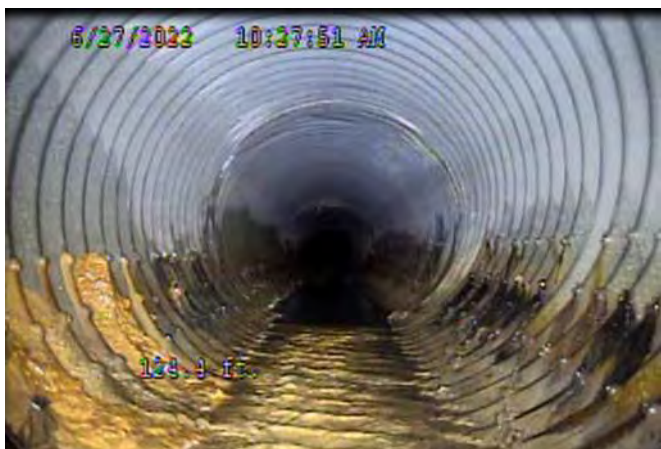
Photo 1: Infiltration/mineralization through perforations

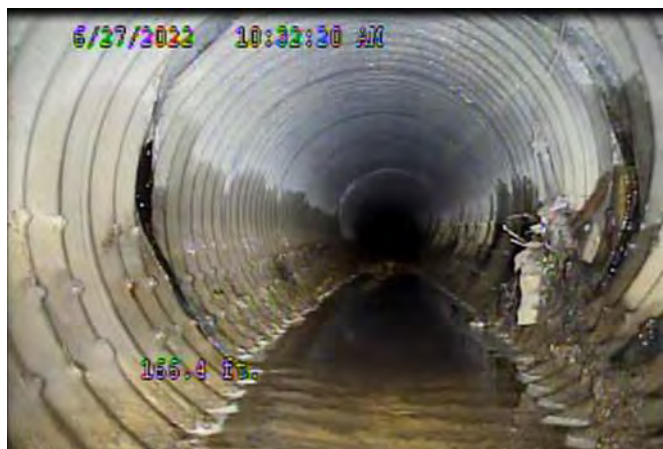
Photo 2: Debris in pipe

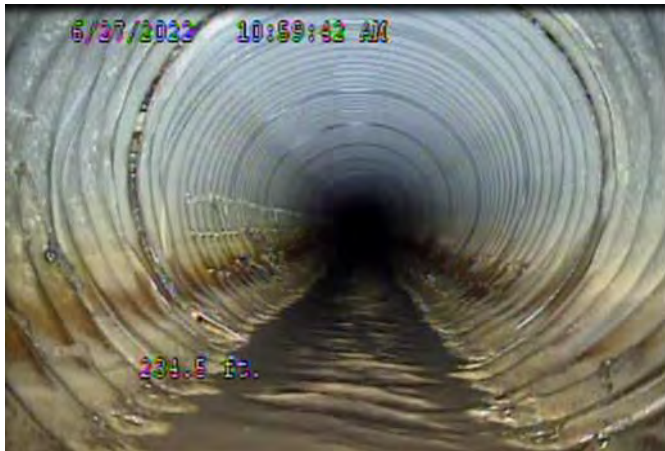
Photo 1: Separated pipe joint

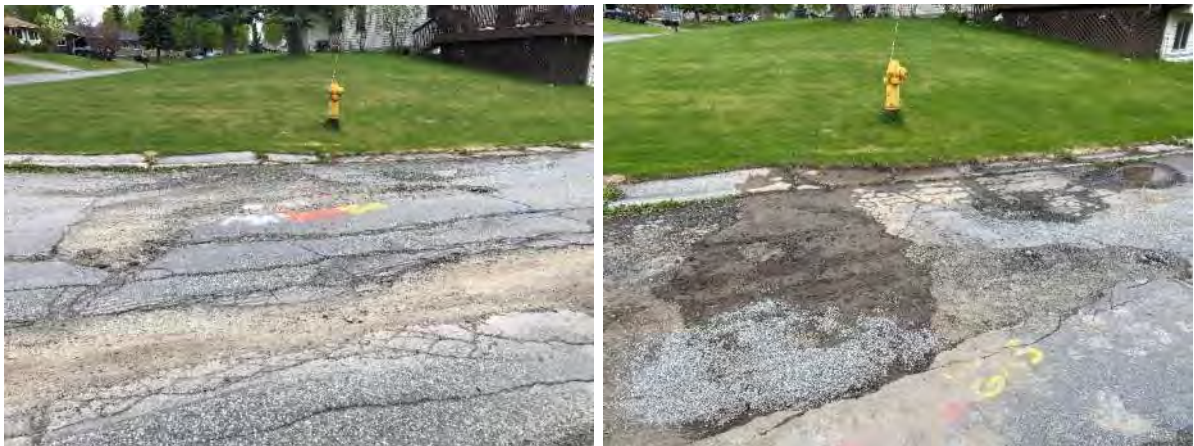
06/02/2021: BH-04 before drilling with utility markings (left) and after completion (right), backfilled with cuttings and gravel spread at surface. Two locations were cleared for BH-04, and the easternmost location was drilled because the pavement showed the most distress.
