# Design Study Memorandum

## Tasha Drive Reconstruction

MOA PM&E Project #20-15

December 2022

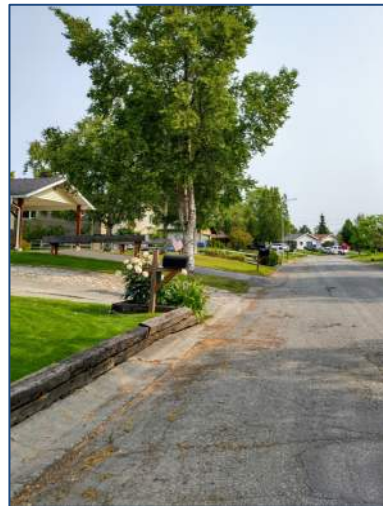
Each property has a single mailbox in the ROW behind the curb and a driveway that extends to the curb. Other private improvements within the ROW include fences, retaining walls, shrubs, boulders, sprinkler systems, and mature trees. These items are not allowed to be located within the ROW and hinder MOA Street Maintenance Department activities, especially snow removal and storage.

*Existing Mailboxes and Landscaping*

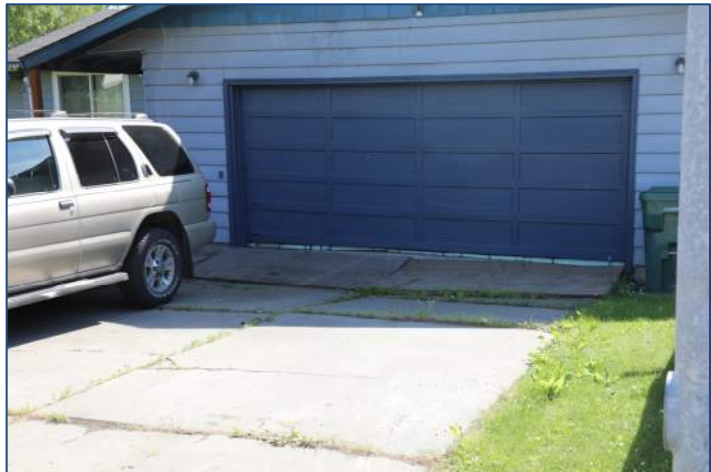
- There are 25 single-family homes in the project area with some driveways located closely together. The closely spaced driveways limit available snow storage.
- Many of the driveways have no landings, grades steeper than maximum allowable grade of 10%, or have negative slopes back toward the ROW.
- Roadway grades vary from about 4% to flat and there are known surface drainage issues in the project area.
- Residents may perceive the grassed ROW area in front of their house as part of “their front yard.” Reconstructing the roadway and impacting those improvements, may be perceived as impacting private property. Also, many private improvements extend into the ROW.

*Existing Driveway Sloping Towards ROW*

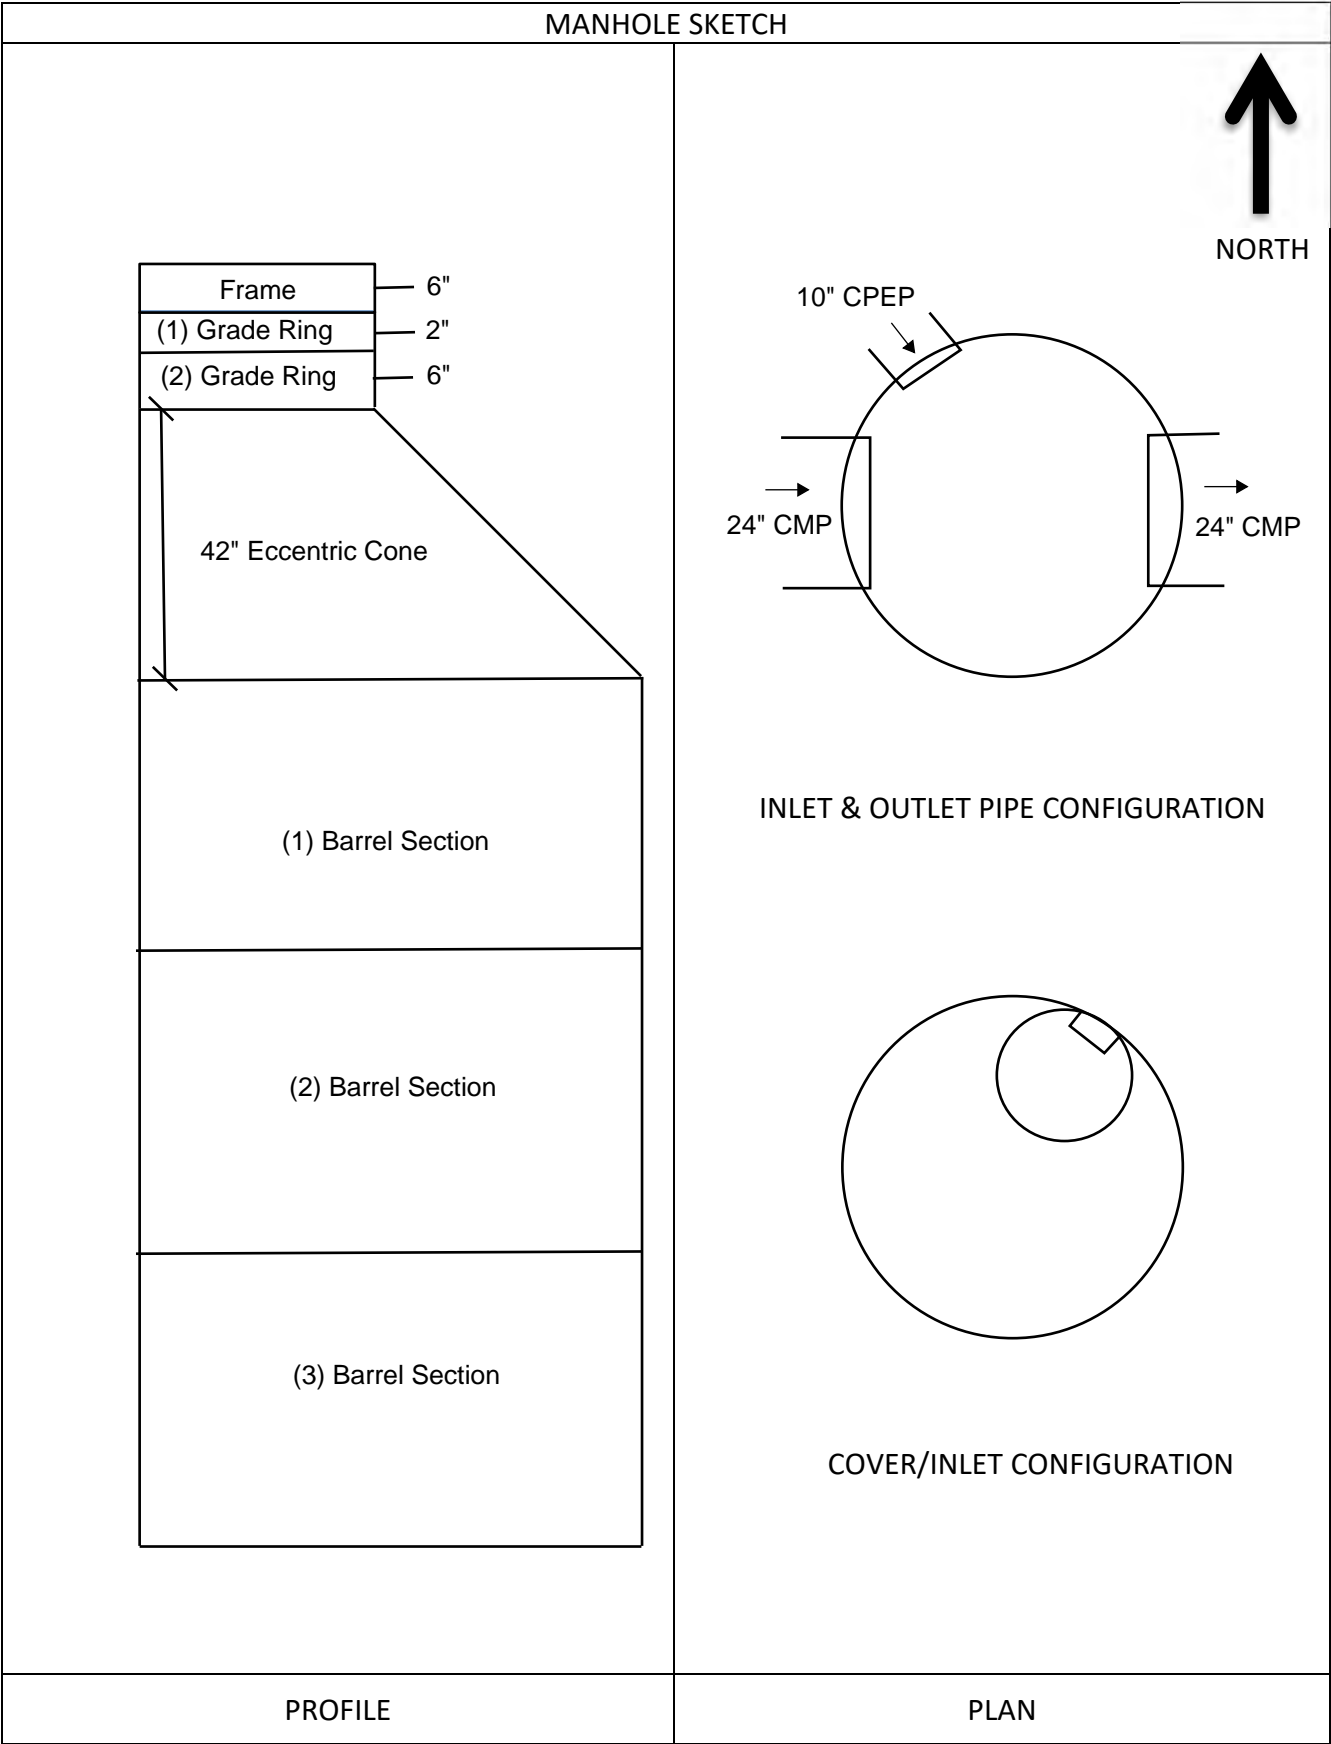
**Structure 32327-037**

- Eccentric Cone
- Metal loss present on frame and cover
- (10) Non-standard metal ladder rungs – missing 2 rungs near MH base due to pipe conflict
- No flow from leads at time of inspection
- Sump full of water/runoff – unable to inspect
- (2) Grade rings – both in good condition (no cracking or spalling)
- Non-standard cover
- Structure in overall good condition

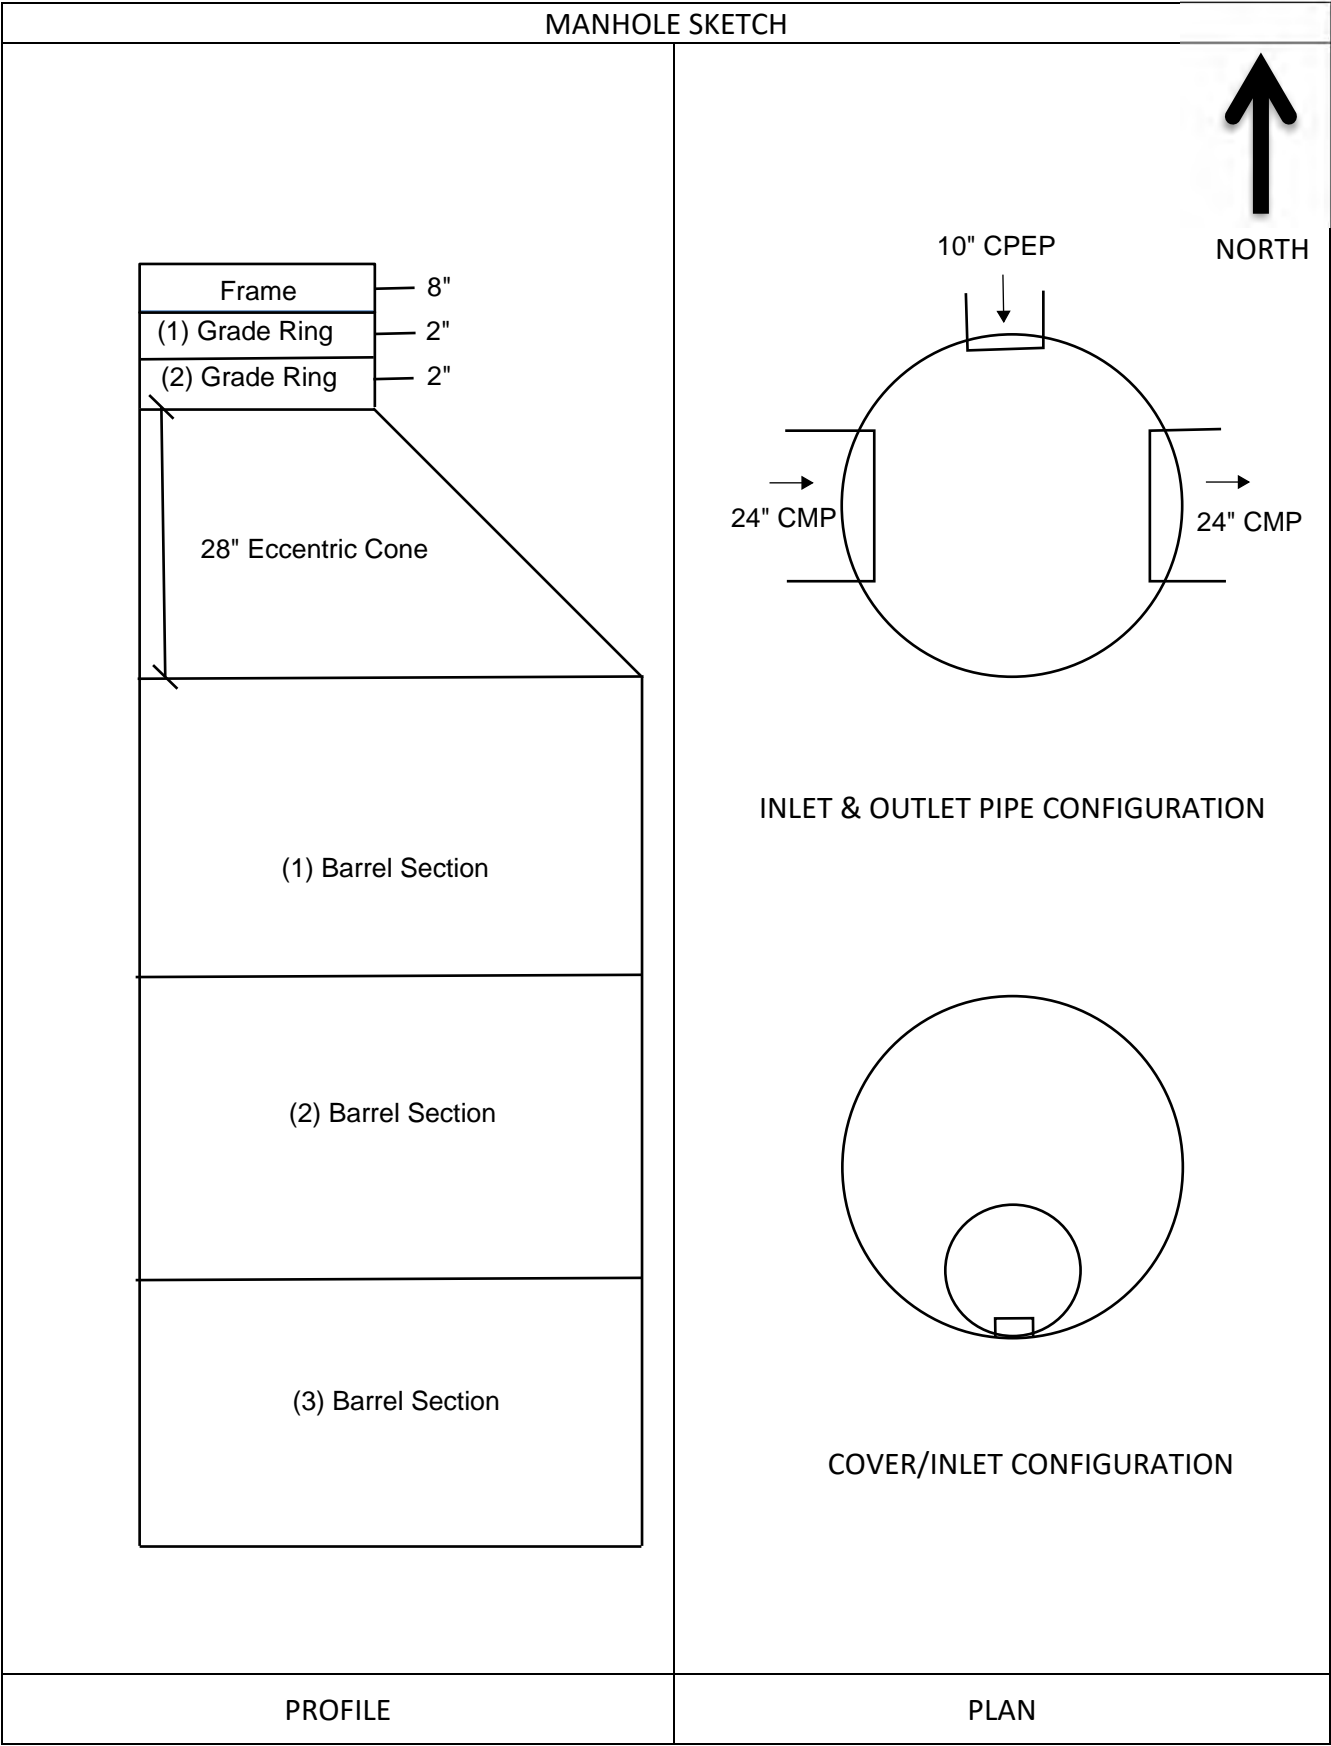
**Structure 32327-118**

- Eccentric cone
- Metal loss present on frame and cover
- Vertical cracking, spalling and concrete loss from grade rings
- (14) Non-standard metal ladder rungs
- No flow from lead at time of inspection
- Sump full of water/runoff – unable to inspect
- (2) Grade rings – both in poor condition (cracks, concrete loss)
- Non-standard cover
- Structure in overall good condition

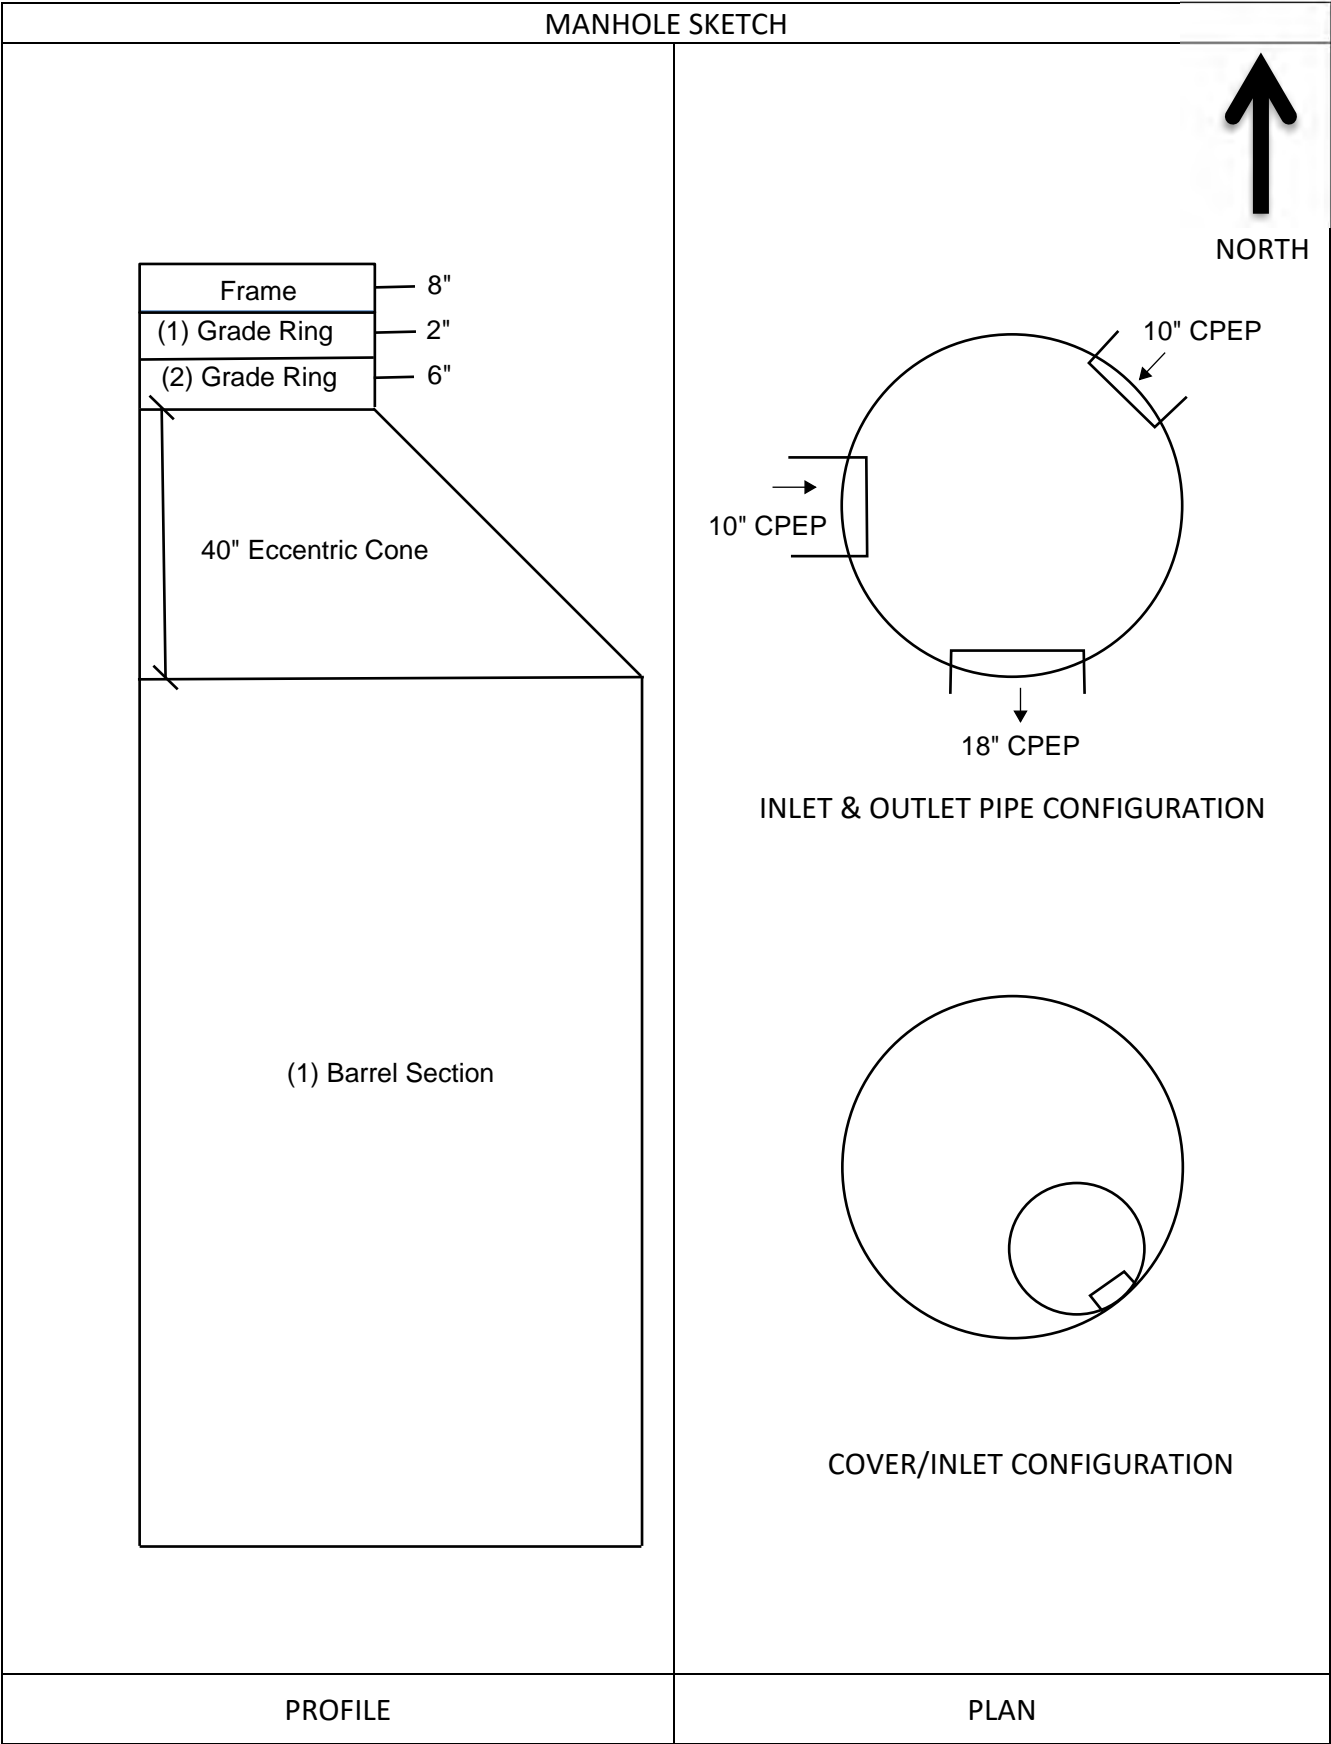
**Structure 32327-174**

- Eccentric cone
- Metal loss present on frame
- (5) Non-standard metal ladder rungs
- Non-standard cover
- Sump full of water/runoff – unable to inspect
- Spalling and concrete loss from grade rings
- Metal shims/spacers added to account for concrete loss in grade rings
- Minor cracking/spalling at pipe penetrations
- Structure in fair condition

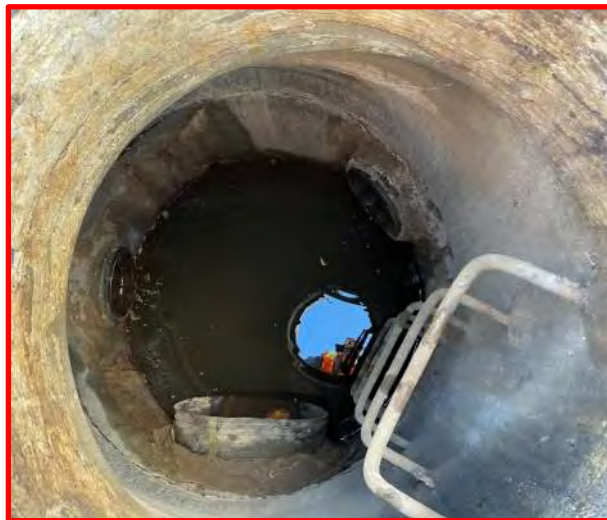
*Photo 4 - Interior of Manhole*

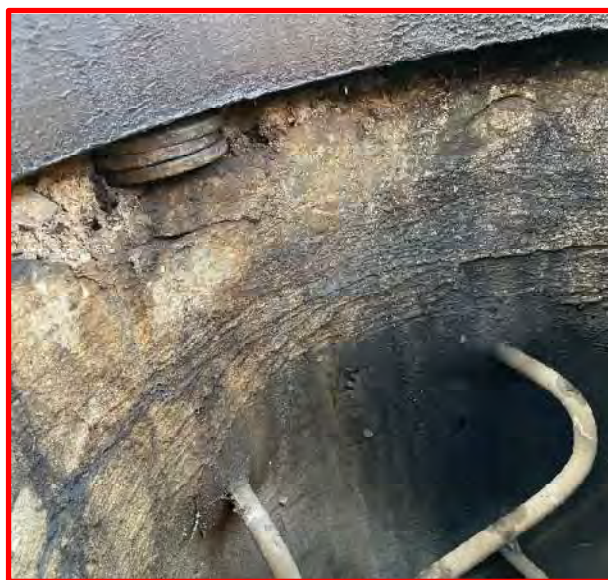
*Photo 5 - Metal Shims/Spacers in Grade Ring*

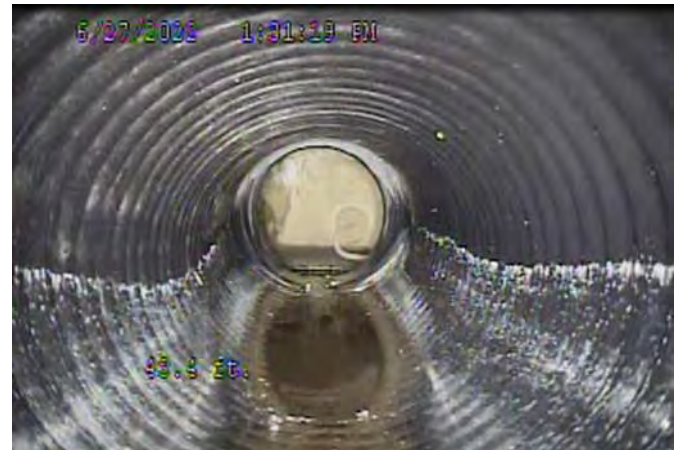
*Miscellaneous/Defect Notes:* Separated pipe joints (20' & 40' downstream from 32327-122).  
Belly/low point (44' downstream from 32327-122). Historic high water mark near springline of pipe.

Photo 2: Belly/low point in pipe

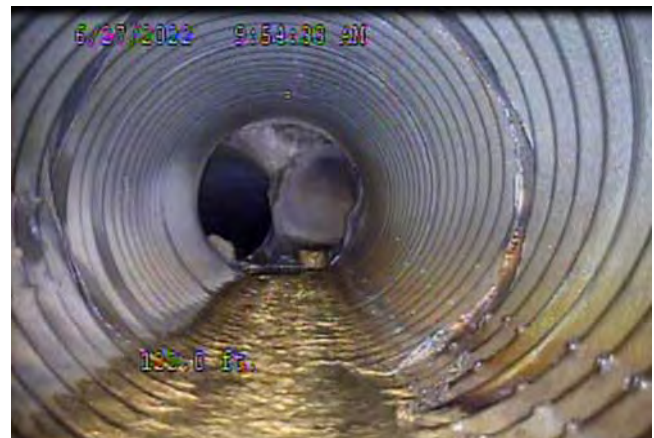
*Miscellaneous/Defect Notes:* Mineral deposit at pipe joints (60' & 100' upstream from 32327-118). Separated pipe joint (122' upstream from 32327-118). Historic high water mark near springline of pipe. Corrosion/mineralization present below springline at perforations and at pipe joints throughout pipe segment.

Photo 2: Separated pipe joint

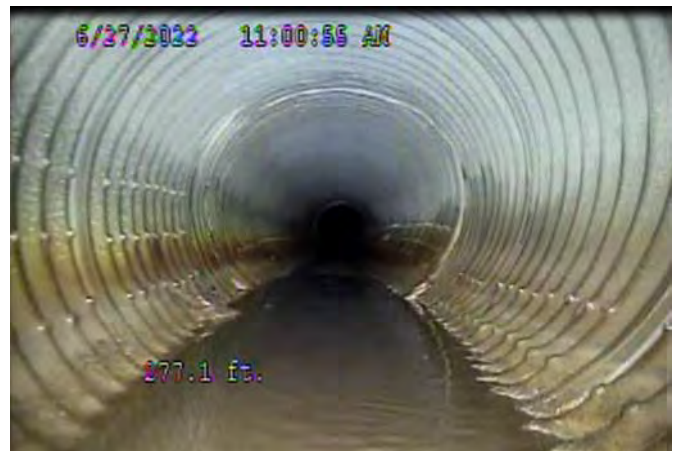
*Miscellaneous/Defect Notes:* Separated pipe joints (186' & 235' downstream from 32327-037).  
Belly at pipe joint (278' downstream from 32327-037). Historic high water mark near springline of pipe.

Photo 2: Belly in pipe
